# Manhole Inspection Summary

Manhole # S47K2\_004MH

Insp Date: **1/16/08 1:33 PM**

**Location** Address: **Ceddox-benhill Alley**

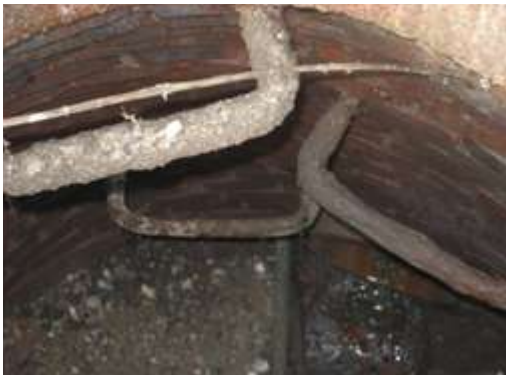
**Steps** Count: **3** Missing: **0** ☒ **Corroded**

steps

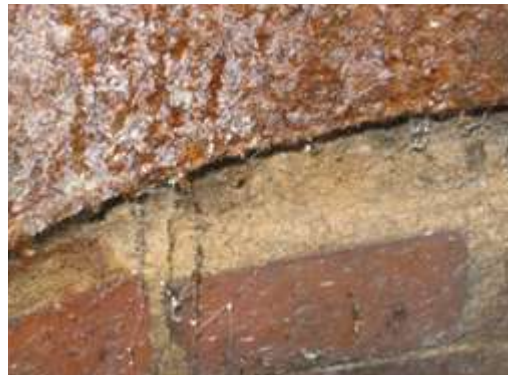
Defect 2

Condition: ☐ Sound ☐ Cracked ☐ Root Intrusion ☒ **Loose Brick** ☐ Deteriorated

bricks missing under frame

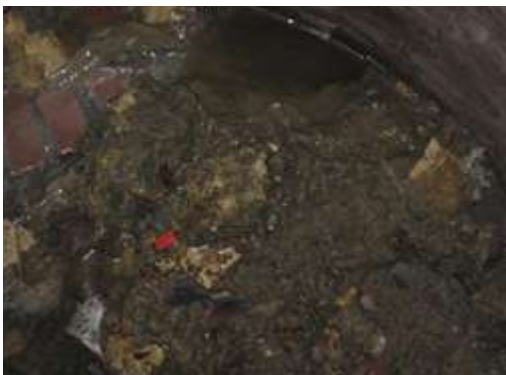
Defect 1

Condition: ☐ Sound ☐ Cracked ☐ Root Intrusion ☐ Deteriorated ☐ Leaks ☒ **Debris**

debris on bench and in channel

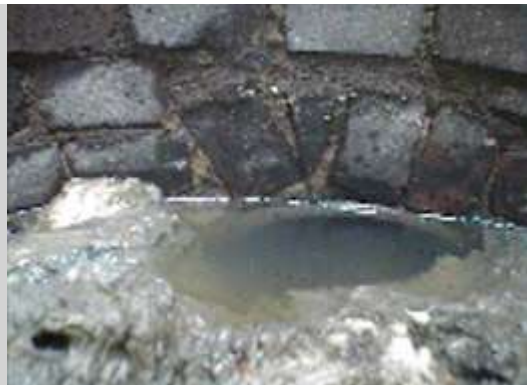
3 O'Clock Inflow

Pipe Height: **8.4** (in.) Rod and Bar (Angled)  
Pipe Material: **Clay** ☐ Pipe Lined  
Invert Depth: **6.60** (ft.) Flow Characteristics: **None**  
Deposits: ☐ None ☐ Mud ☒ **Sludge** ☐ Debris ☐ Grease  
Silt Depth: **4** (in.) Deposits Extent: **Heavy**  
Infiltration: **None** Pipe Seal Cond: **Sound**

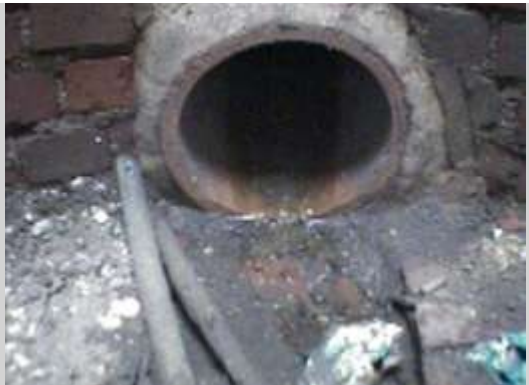
9 O'Clock Inflow

Deposits: ☐ None ☐ Mud ☒ ~~Sludge~~ ☐ Debris ☐ Grease

Silt Depth: **3** (in.) Deposits Extent: **Medium**
